APPENDIX A6.2 – Peat Slide Risk Assessment

Appendix A6.2 Peat Slide Risk Assessment

Date:	10/10/2021	Job reference:	14220UKC
Issue:	B	File name:	
Description:	Peat Slide Risk Assessment – <i>Updated with additional detailed probing 07/22</i>		
Prepared by:	Sam Fisher	Checked by:	Gavin Germaine
Edited/checked:	Gavin Germaine	Date:	15/10/2021
Client review:		Date:	
Legal review:		Date:

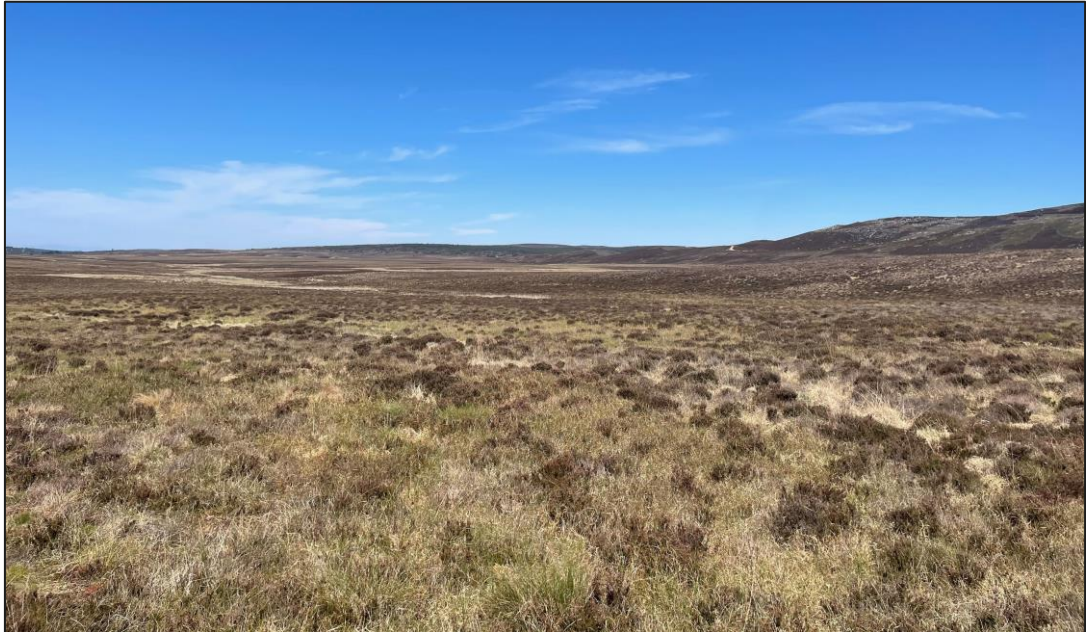
Figure 1.7.1 – Typical Site Terrain – note absence of slopes in main site area

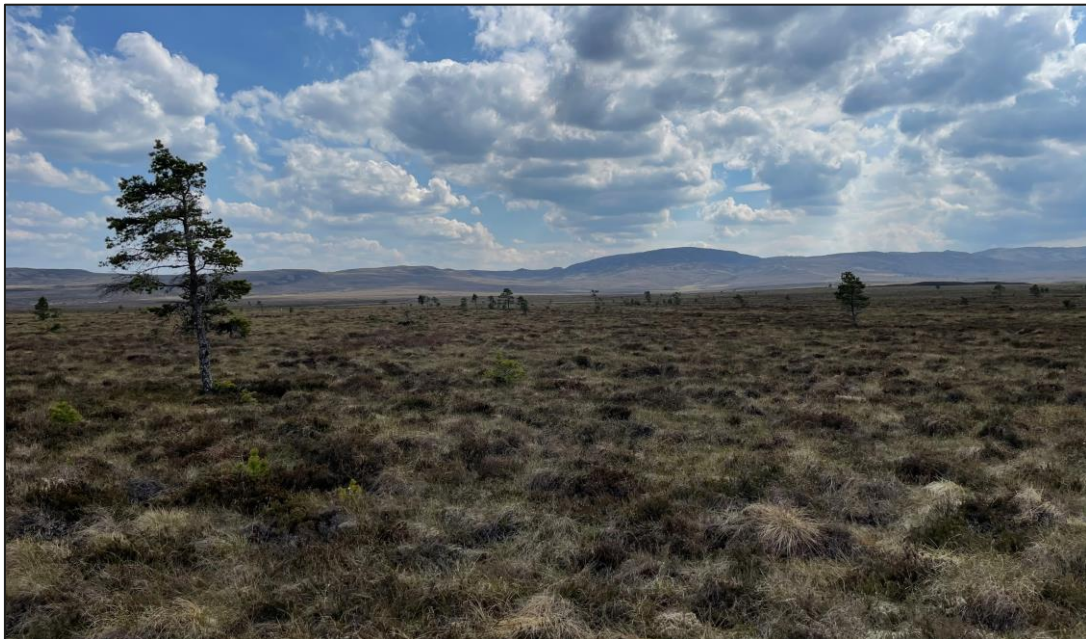
Figure 1.7.2 – Typical Site Terrain - note absence of slopes in main site area

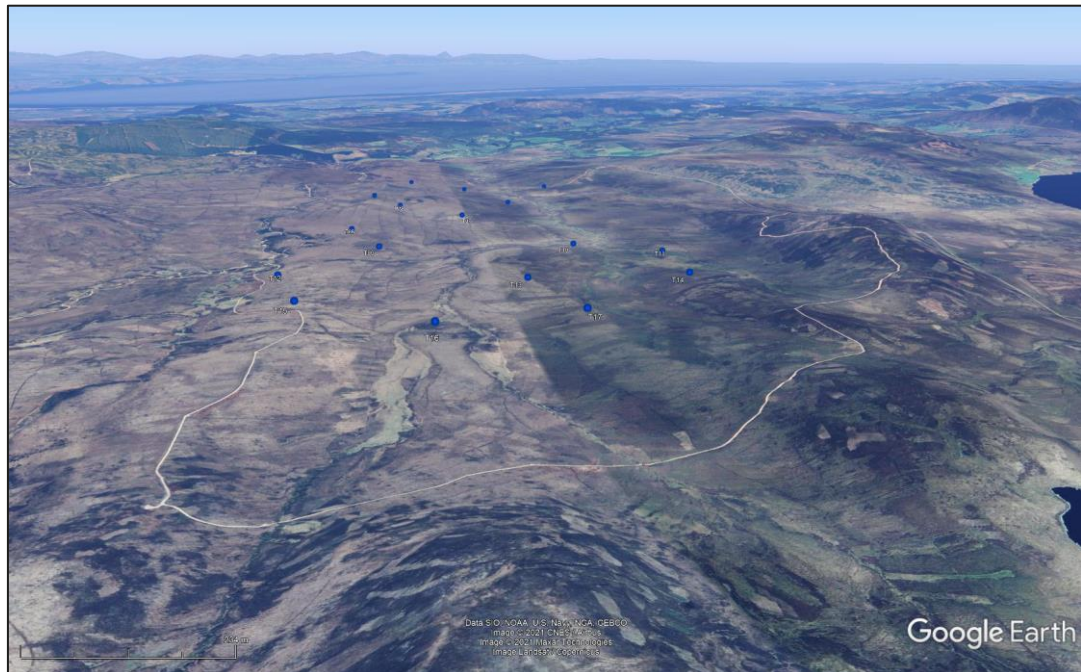
- 1.8.3 Figure 1.7.3 provides an overview of the terrain across the development. Showing a generally encapsulated low angled terrain bordered to the east, south and west by rising terrain elevations. There are no continuous steep slopes within the development.

Figure 1.7.3 – 3D Terrain View

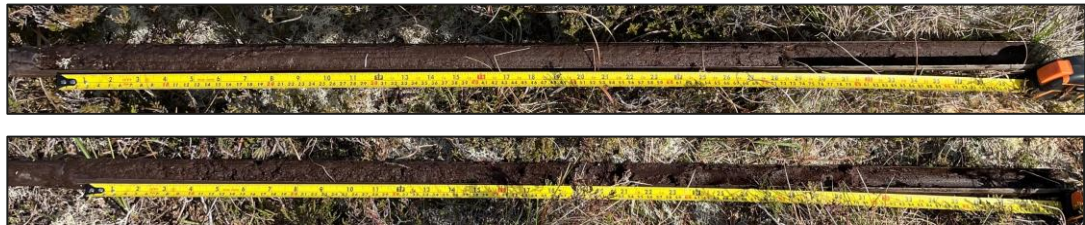
4.2.6 The peat encountered across the development is typically soft to very soft and fibrous in the acrotelmic surface layer. In the deeper deposits, characteristically humification increases with depth at the catotelmic layer.

Figure 4.2.1 – Typical peat core taken from 75 Southwest of Turbine T03.

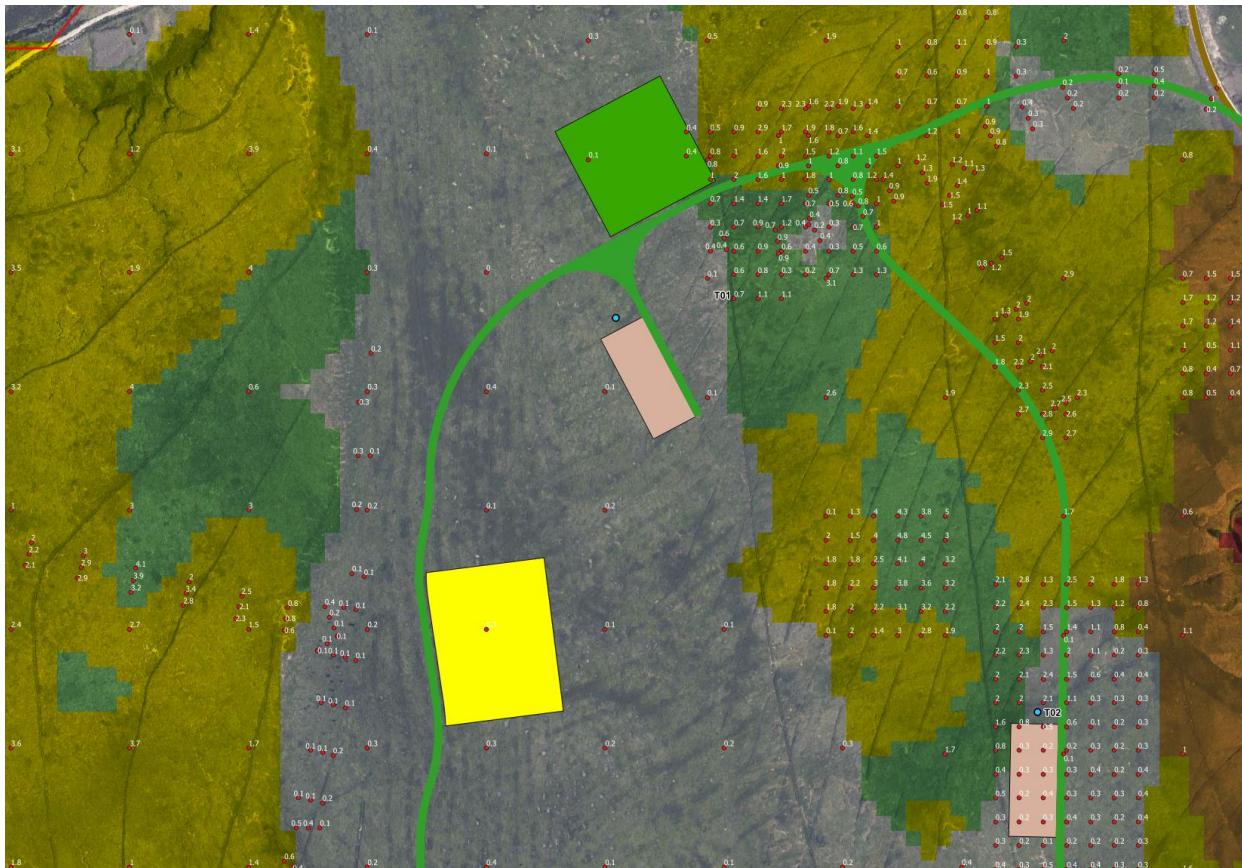
T01 Location – Bing Aerial Imagery – 1:3,000 Scale

WTG ID	Impact Scale Environment & Infrastructure	Contributory Factors (Probability/Exposure)	Risk Ranking Residual Risk
T01 Temporary Compound 1 Substation	1	Peat Depth - Absent	0
		Slope Angle (3-9°)	3
		FoS	1
		Peat cracking / Infiltration	1
		Groundwater Flow	1
		Hydrology	1
		Previous Instability	1
Land Management	2		
			Negligible (No Peat)

- Following further intrusive site investigation post-consent, the risk ranking should be re-evaluated. The risk should remain negligible as peat is absent at this location.
- Existing drainage ditches and hydrological regime should be maintained and prevented from blocking leading to increased power water pressures in surrounding peatland to northwest;

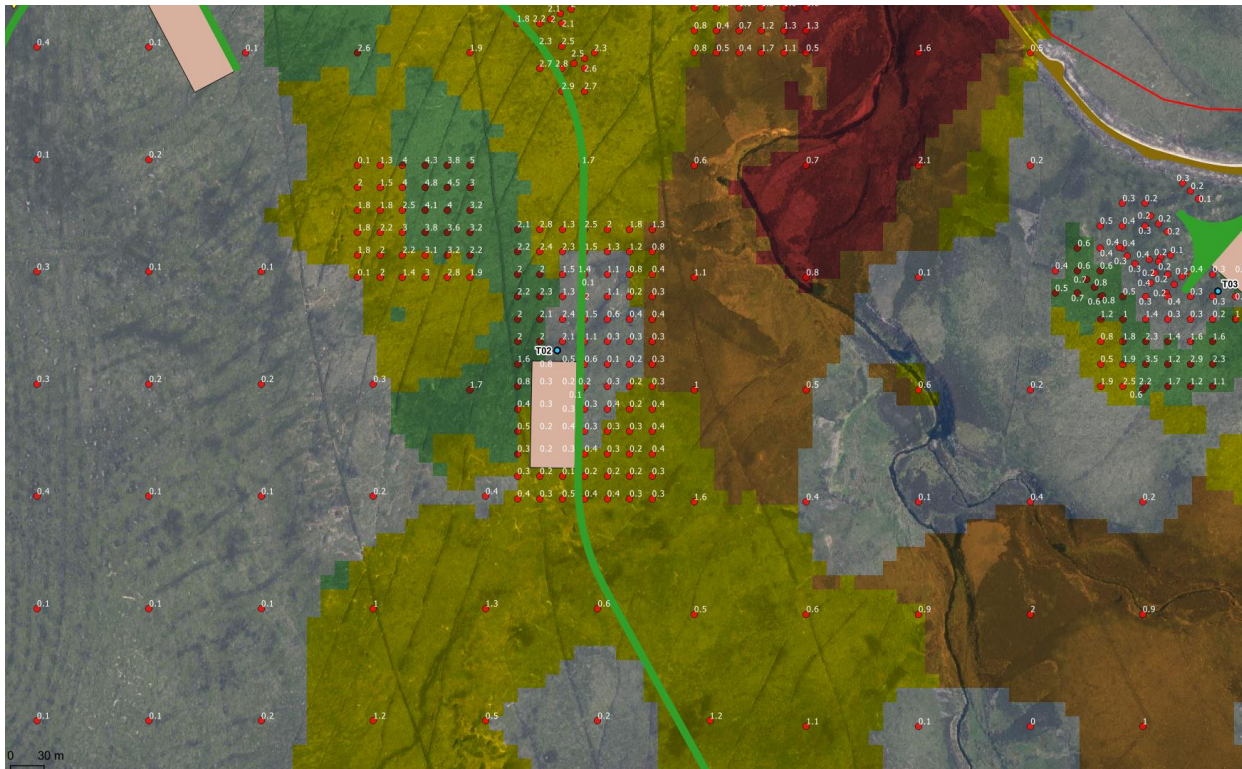
T02 Location – Bing Aerial Imagery – 1:3,000 Scale

WTG ID	Impact Scale Environment & Infrastructure	Contributory Factors (Probability/Exposure)	Risk Ranking Residual Risk
T02	1	Peat Depth (0.5m)	3
		Slope Angle (3-9°)	3
		FoS	1
		Peat cracking / Infiltration	1
		Groundwater Flow	1
		Hydrology	1
		Previous Instability	1
Land Management	1		
			Low <u>6</u>
			Negligible

- Turbine has been micro-sited onto shallowest peat deposits.
- Following further intrusive site investigation post-consent, the risk ranking should be re-evaluated. The risk should remain negligible through the use of low impact construction techniques and best practice methods for construction over peatland.
- No temporary storage or stockpile of earthworks material downslope to the north of the turbine position.

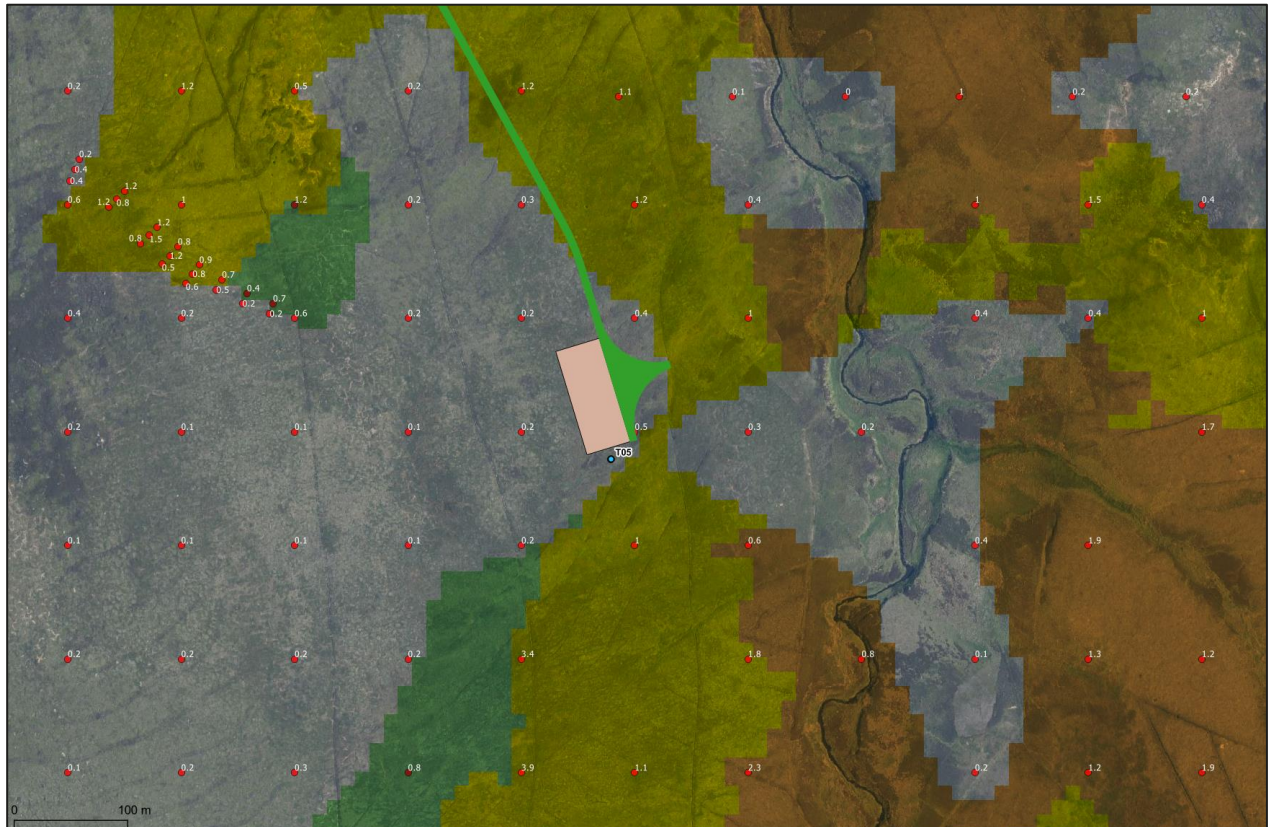
T05 Location – Bing Aerial Imagery – 1:3,000 Scale

WTG ID	Impact Scale Environment & Infrastructure	Contributory Factors (Probability/Exposure)	Risk Ranking Residual Risk
T05	2	Peat Depth (Mean = 0-0.5m)	1
		Slope Angle (>3-9°)	3
		FoS	1
		Peat cracking / Infiltration	1
		Groundwater Flow	1
		Hydrology	1
		Previous Instability	1
		Land Management	1
			(Low) 6
			Negligible

- Following further intrusive site investigation post-consent, the risk ranking should be re-evaluated. Peat survey indicated limited peat at this location soil probes 0.2 – 0.5m.

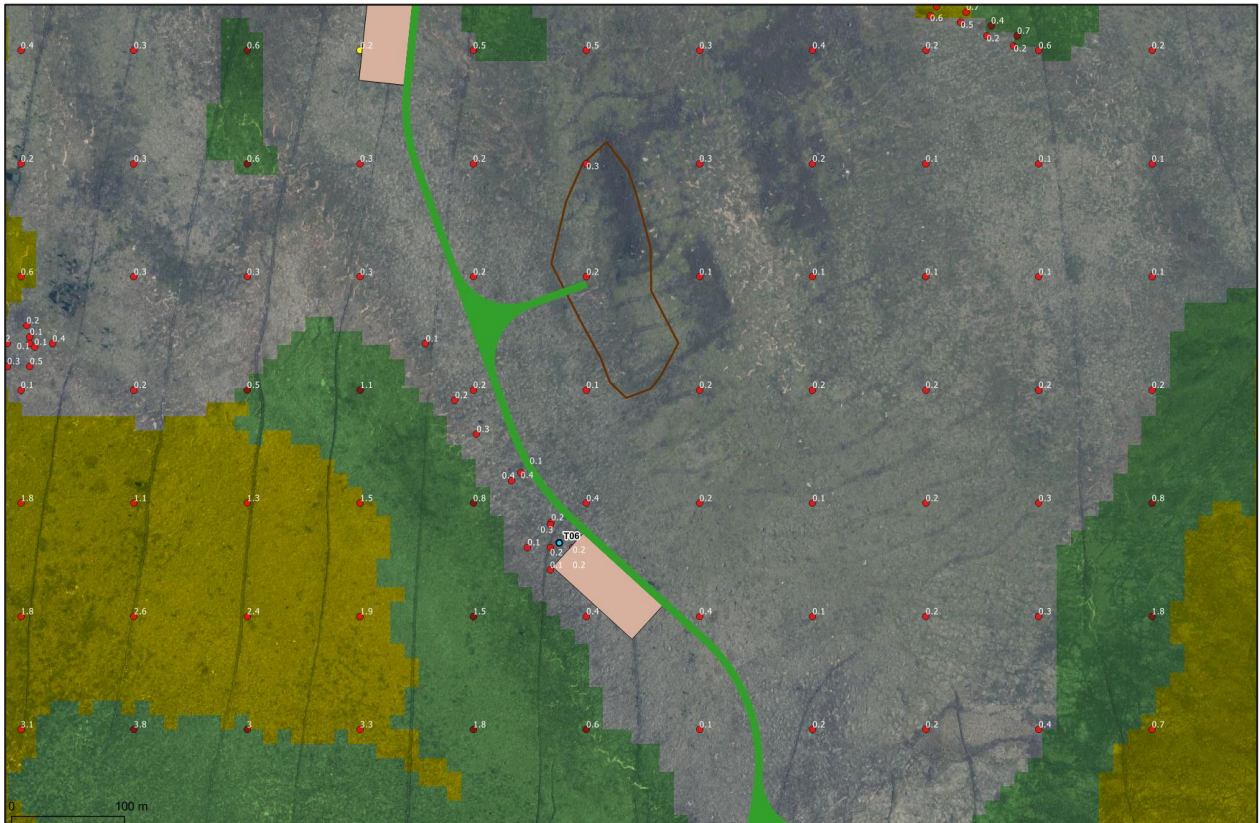
T06 Location – Bing Aerial Imagery – 1:2500 Scale

WTG ID	Impact Scale Environment & Infrastructure	Contributory Factors (Probability/Exposure)	Risk Ranking Residual Risk
T06	1	Peat Depth Absent	0
		Slope Angle (<3°)	1
		FoS	1
		Peat cracking / Infiltration	1
		Groundwater Flow	1
		Hydrology	1
		Previous Instability	1
		Land Management	1
			Negligible (No Peat)

- Following further intrusive site investigation post-consent, the risk ranking should be re-evaluated. The risk should remain negligible as there are not conditions present at the turbine foundation which may give rise to a peat slide. Peat is absent and terrain slope angle is very shallow.

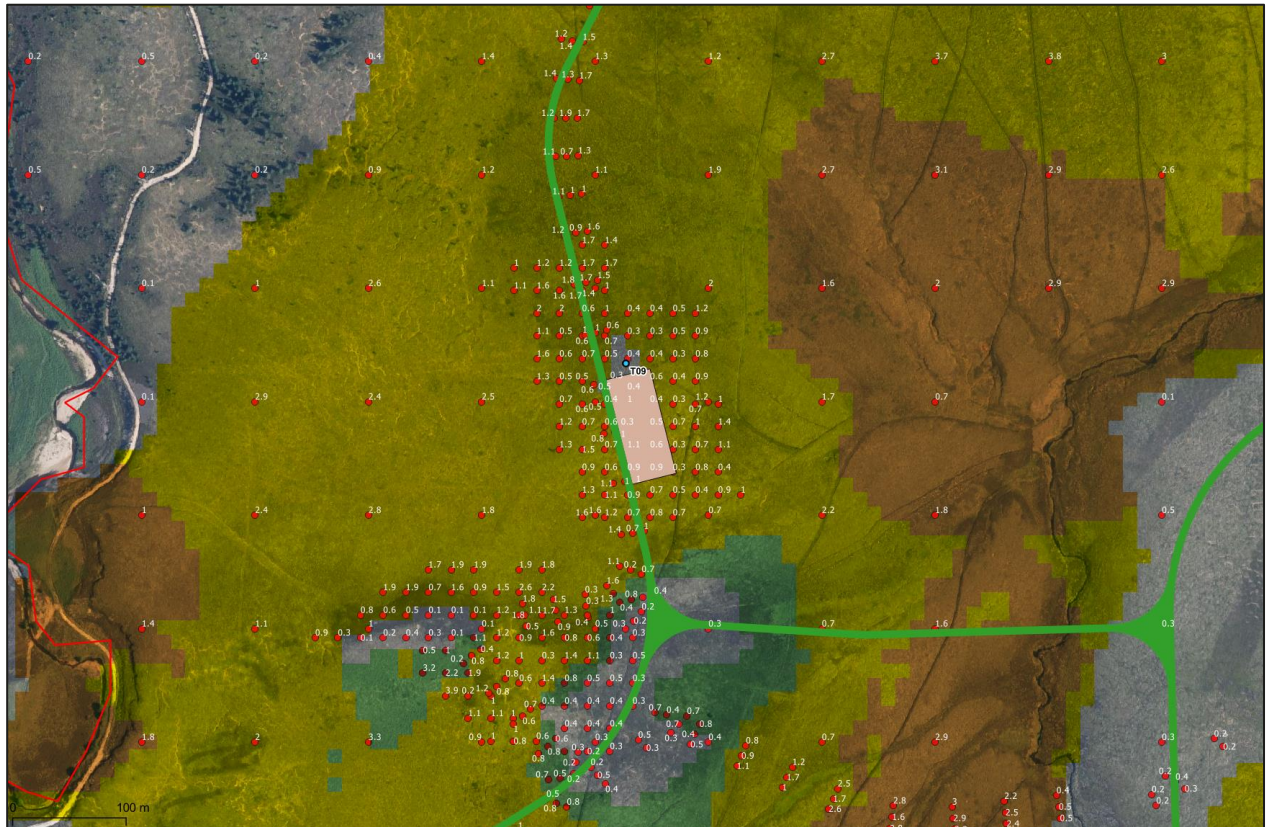
T09 Location – Bing Aerial Imagery – 1:2,500 Scale

WTG ID	Impact Scale Environment & Infrastructure	Contributory Factors (Probability/Exposure)	Risk Ranking Residual Risk
T09	1	Peat Depth (Mean = 0.6m)	3
		Slope Angle (<3°)	1
		FoS	1
		Peat cracking / Infiltration	1
		Groundwater Flow	1
		Hydrology	1
		Previous Instability	1
		Land Management	2
			Low <u>5</u>
			Negligible

- Following further intrusive site investigation post-consent, the risk ranking should be re-evaluated. The risk should reduce to negligible given the shallow slope angle;
- There should be no temporary stockpiling of peat materials on peat deposits >0.5m depth.
- There should be no stockpiling of peat or earthworks on the deep peat deposits towards the west of the turbine position.

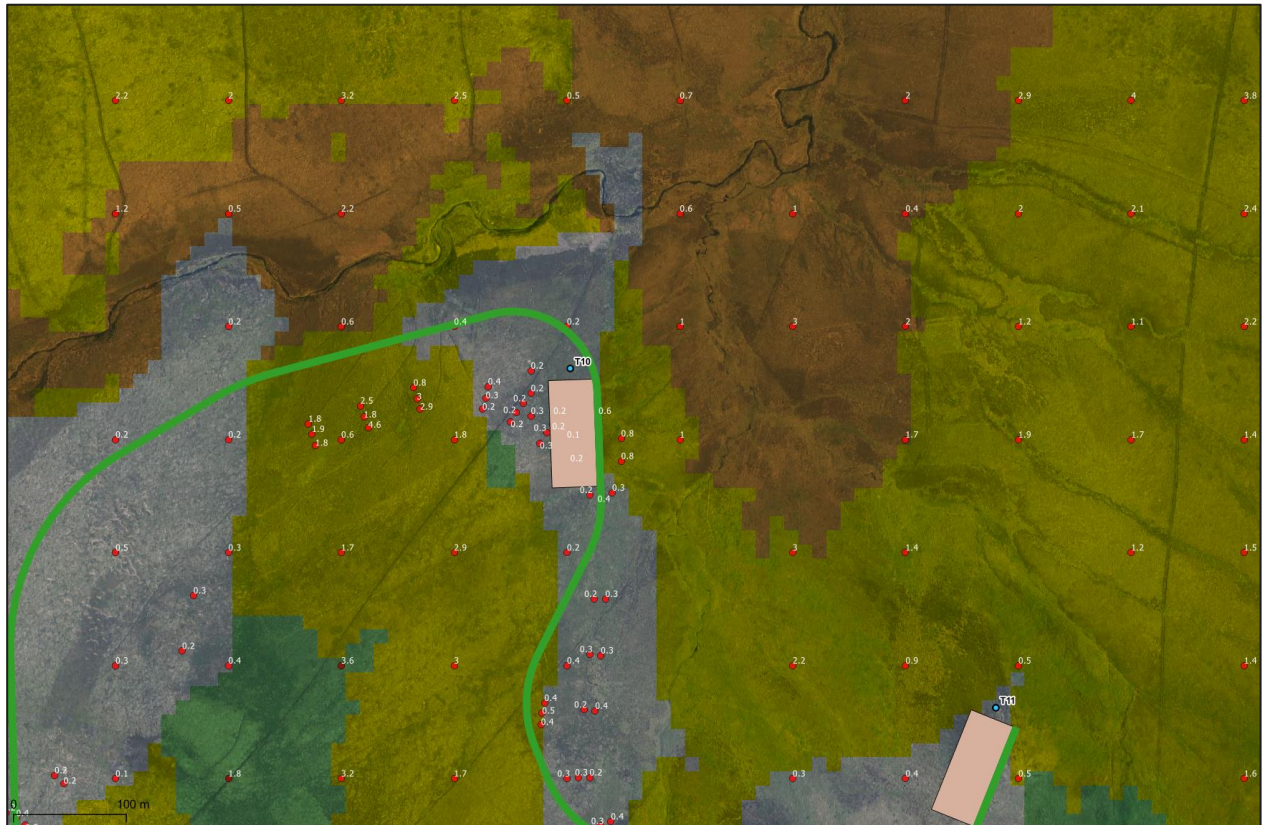
T10 Location – Bing Aerial Imagery – 1:3,000 Scale

WTG ID	Impact Scale Environment & Infrastructure	Contributory Factors (Probability/Exposure)	Risk Ranking Residual Risk
T10	2-3	Peat Depth – Peat Absent	0
		Slope Angle (<3°)	1
		FoS	1
		Peat cracking / Infiltration	1
		Groundwater Flow	1
		Hydrology	1
		Previous Instability	1
		Land Management	1
			Negligible (No Peat)

- Following further intrusive site investigation post-consent, the risk ranking should be re-evaluated. The risk should remain negligible due to the absence of peat and shallow terrain slope angles.
- There should be no temporary stockpiling of peat materials west of the infrastructure where peat depths are indicated to increase.

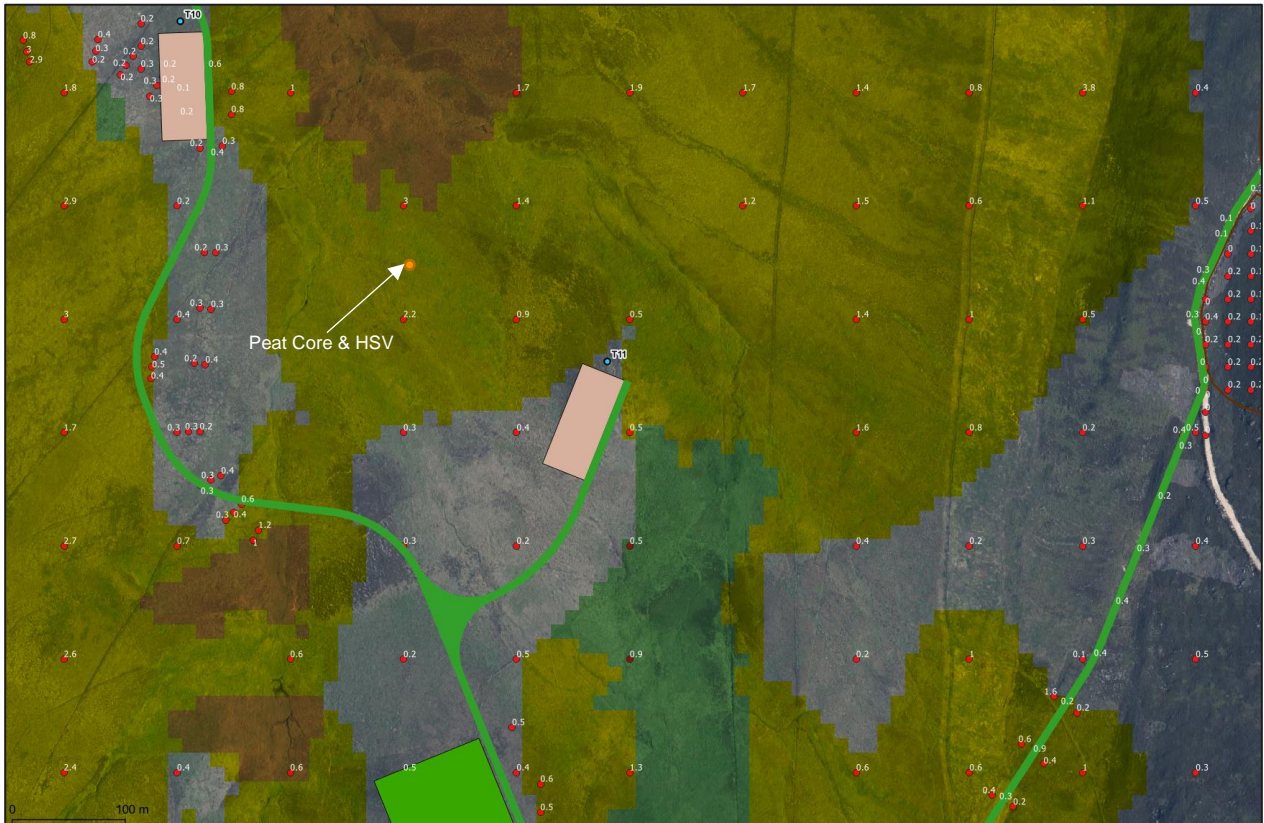
T11 Location – Bing Aerial Imagery – 1:3,000 Scale

WTG ID	Impact Scale Environment & Infrastructure	Contributory Factors (Probability/Exposure)	Risk Ranking Residual Risk
T11	2-3	Peat Depth (0.4-0.5m)	1
		Slope Angle (3-9°)	3
		FoS	1
		Peat cracking / Infiltration	1
		Groundwater Flow	1
		Hydrology	1
		Previous Instability	1
		Land Management	1
			(Low) <u>9</u>
			Negligible

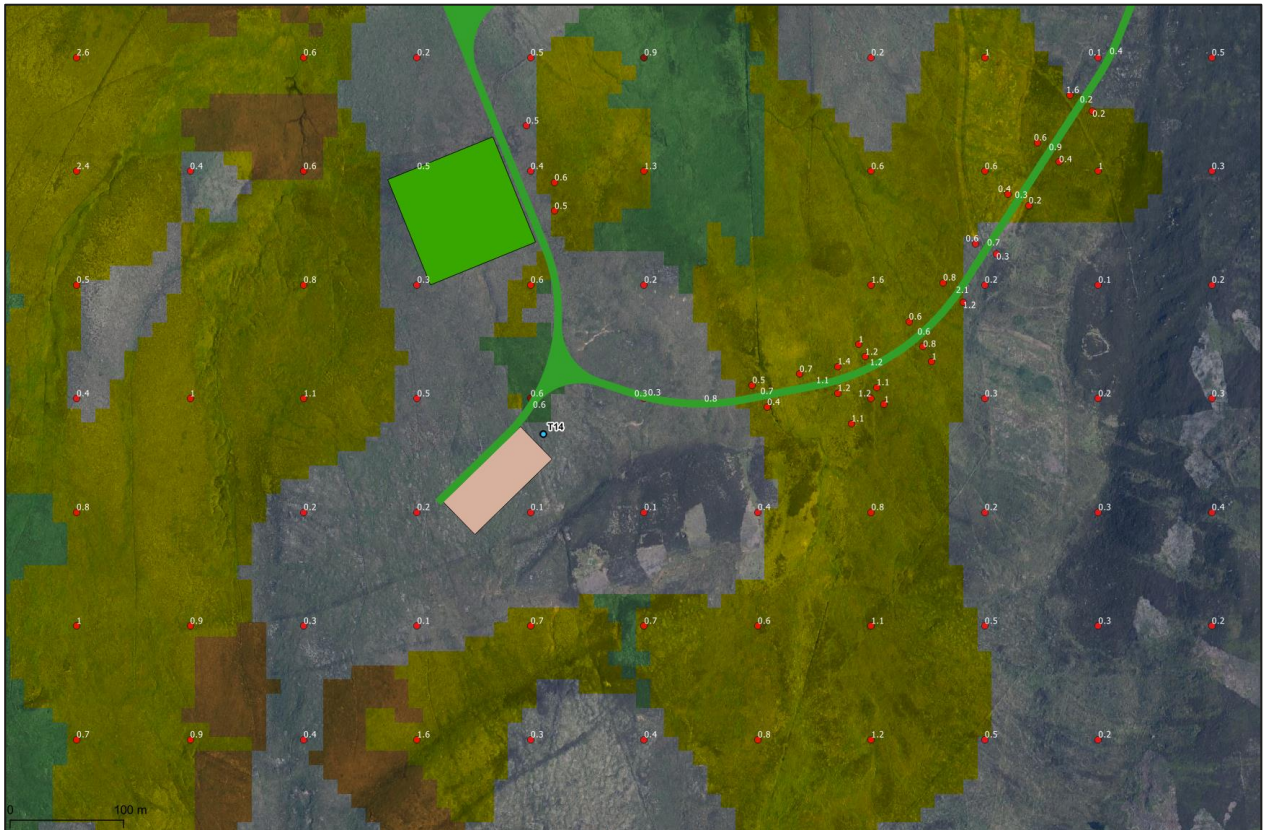
T14 Location – Bing Aerial Imagery – 1:3,000 Scale

WTG ID	Impact Scale Environment & Infrastructure	Contributory Factors (Probability/Exposure)	Risk Ranking Residual Risk
T14	1	Peat Depth (0.1-0.6)	3
		Slope Angle (3-9°)	3
		FoS	1
		Peat cracking / Infiltration	1
		Groundwater Flow	1
		Hydrology	1
		Previous Instability	1
		Land Management	1
			Low
			Negligible

- Following further intrusive site investigation post-consent, the risk ranking should be re-evaluated. The risk should remain low through the use of low impact construction techniques and best practice methods for construction over peatland.

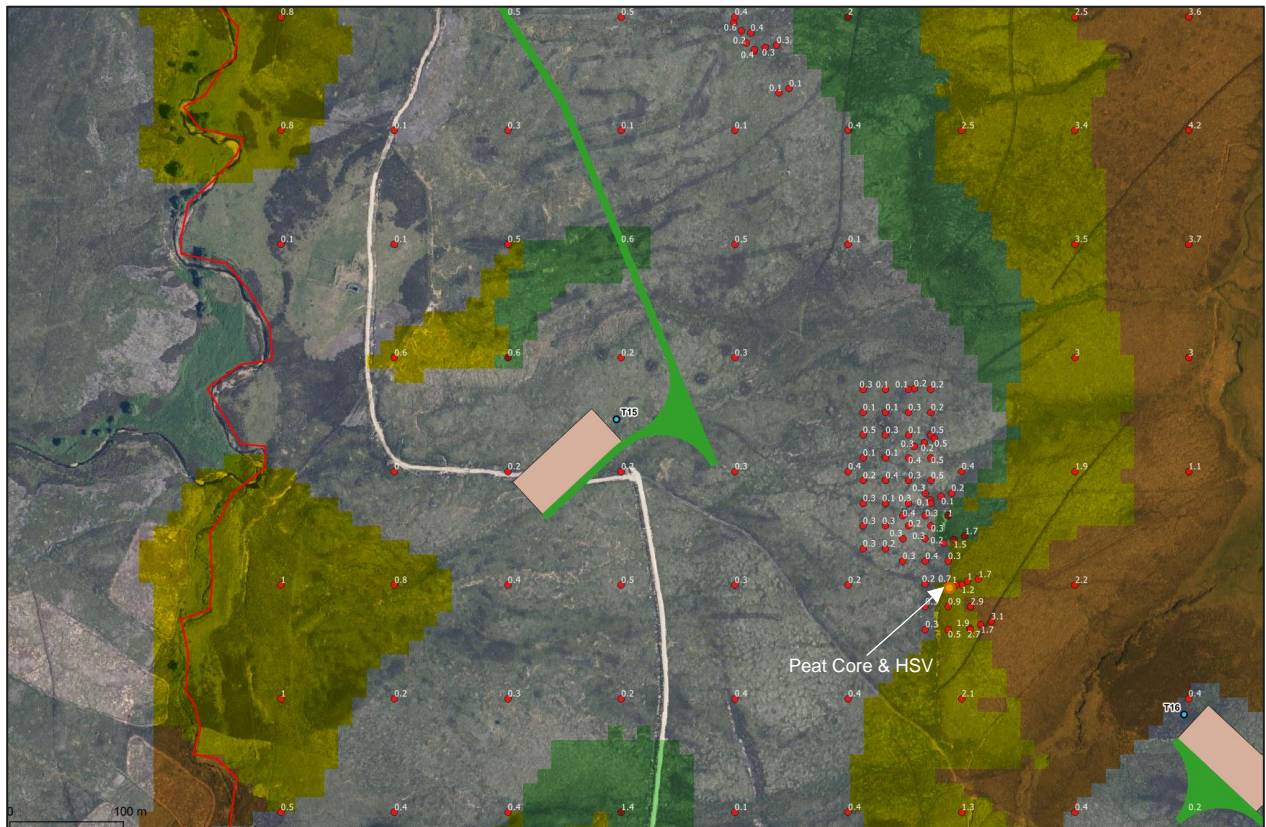
T15 Location – Bing Aerial Imagery – 1:3,000 Scale

WTG ID	Impact Scale Environment & Infrastructure	Contributory Factors (Probability/Exposure)	Risk Ranking Residual Risk
T15	3	Peat Depth (Absent)	0
		Slope Angle (<3°)	1
		FoS	1
		Peat cracking / Infiltration	1
		Groundwater Flow	1
		Hydrology	1
		Previous Instability	1
		Land Management	1
			Negligible (Peat Absent)

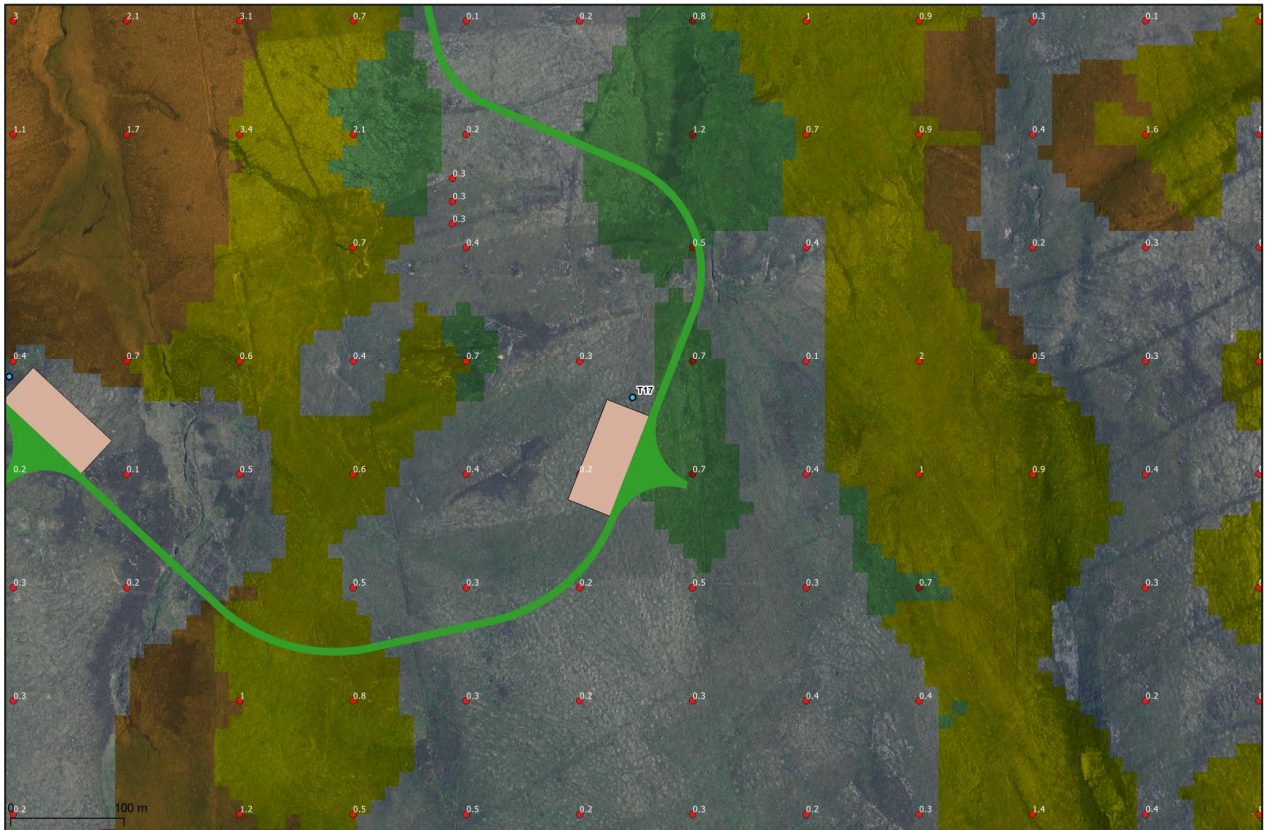
Substation Location – Bing Aerial Imagery – 1:2,500 Scale

WTG ID	Impact Scale Environment & Infrastructure	Contributory Factors (Probability/Exposure)	Risk Ranking Residual Risk
T17	3	Peat Depth (Absent)	0
		Slope Angle (<3°)	1
		FoS	1
		Peat cracking / Infiltration	1
		Groundwater Flow	1
		Hydrology	1
		Previous Instability	1
		Land Management	1
			Negligible (Absent Peat)

- Following further intrusive site investigation post-consent, the risk ranking should be re-evaluated. The risk should remain negligible, there is no record of peat and terrain slope angles are very low.

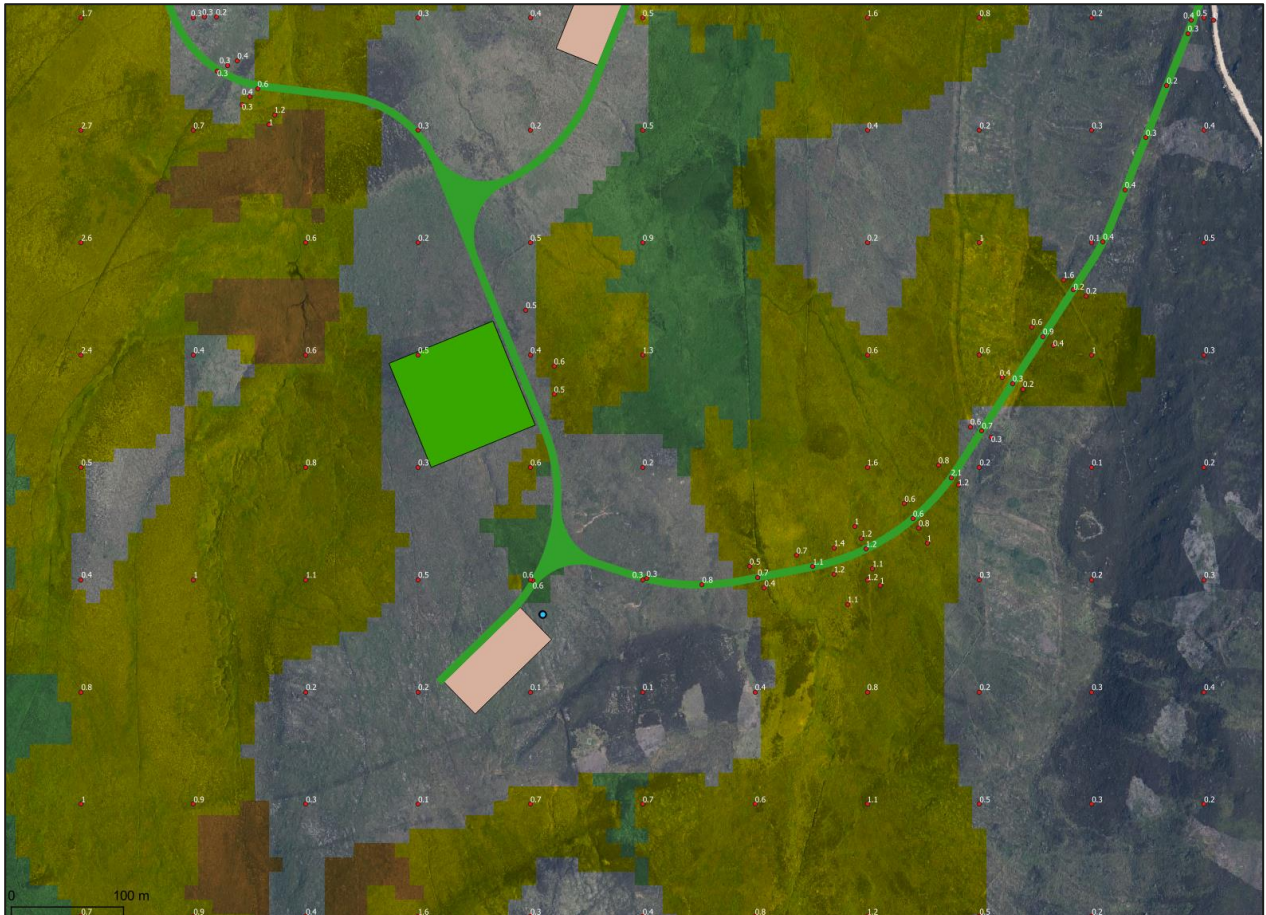
Temporary Compound 2 Location – Bing Aerial Imagery – 1:3,000 Scale

WTG ID	Impact Scale Environment & Infrastructure	Contributory Factors (Probability/Exposure)	Risk Ranking Residual Risk
Temporary Compound 2	1-2	Peat Depth (Peat Absent)	0
		Slope Angle (3-9°)	3
		FoS	1
		Peat cracking / Infiltration	1
		Groundwater Flow	1
		Hydrology	1
		Previous Instability	1
		Land Management (Muirburn Evident)	2
			Negligible (No Peat)

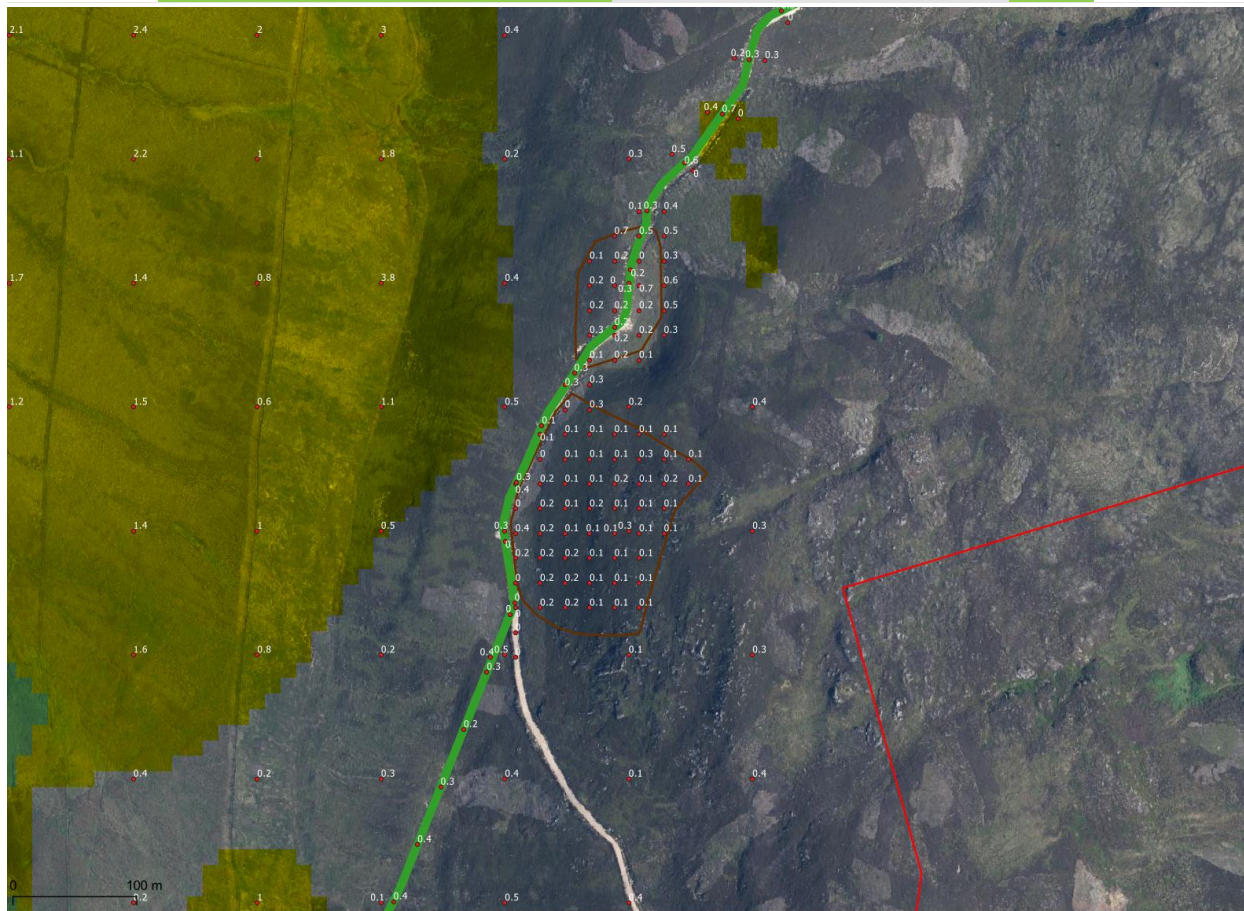
BP2 & BP3 Location – Bing Aerial Imagery – 1:3,000 Scale

WTG ID	Impact Scale Environment & Infrastructure	Contributory Factors (Probability/Exposure)	Risk Ranking Residual Risk
Borrow Pit BP2 & 3	1	Peat Depth (Peat Absent)	0
		Slope Angle (15-20°)	4
		FoS	1
		Peat cracking / Infiltration	1
		Groundwater Flow	1
		Hydrology	1
		Previous Instability	1
		Land Management (Muirburn Evident)	1
			Negligible (No Peat)

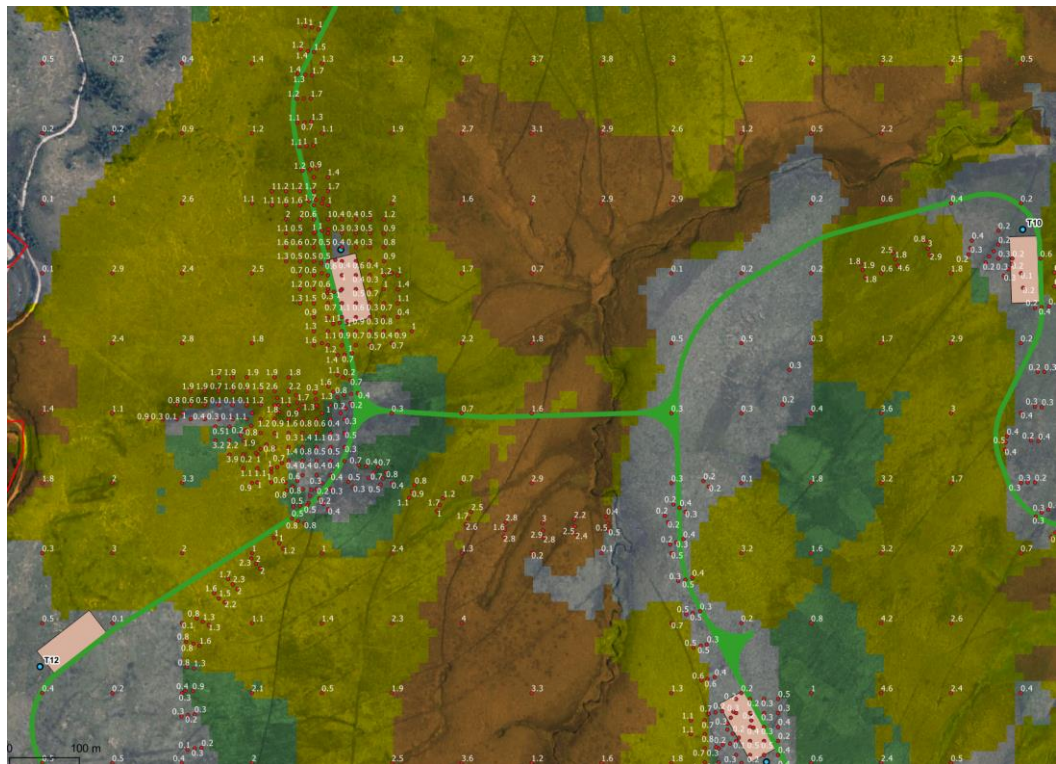
T09 Link Track - **Medium**

- Crossing of main watercourse
- Peat depth – up to 1.6m west of water crossing
- Slope angle increases in immediate vicinity of watercourse otherwise low angle (<3degrees)
